Ynformes de Sn. Jn. Bautista

A Report of the Mission Conservation Program of San Juan Bautista, California – Volume 1, Number 1 – January 28, 2006

The SJB Mission Conservation Program

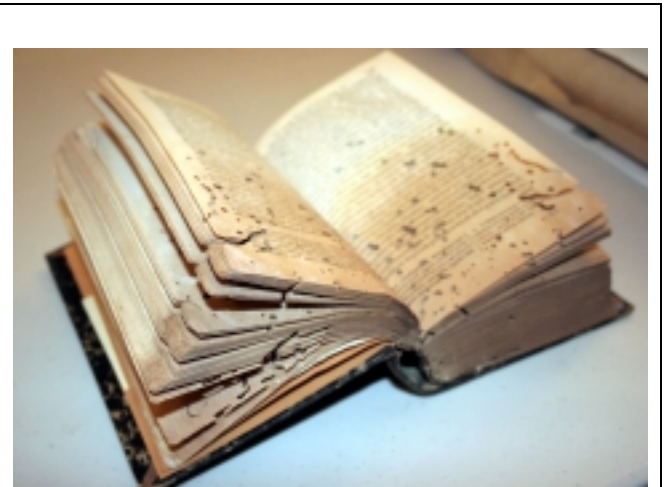
As the result of our preliminary cataloging of Archives Room materials, we found many ancient books, like this 18th century Spanish liturgy, that have been severely damaged by bookworms and other pests. We have consulted with manuscripts conservator Kathleen Orlenko, and will soon work to address the sad state of the Old Mission's manuscript collections. Photo © Ruben G. Mendoza, 2005.

As we now know all too well, moisture, bookworms, and related pests have damaged some 60 Mission period books and manuscripts beyond repair. Some, like that pictured on page 1, have been damaged so severely that they have been lost to history and the liturgy. Many others can be treated by conservators and protected well into the foreseeable future. To address the problem of moisture penetrating the gallery rooms of the Old Mission Museum, Mario Trujillo and his firm were contracted to address the problem under my supervision. As any excavation on sensitive historical sites without the on-site monitoring of an RPA certified (Register of Professional Archaeologists) archaeologist violates both State and Federal statutes, I oversaw and monitored all trenching activities in and about the front entryway of the Mission Church. As an RPA certified archaeologist, I have had many an occasion to assess, recommend, or see through such monitoring, and have thereby averted the destruction of key historical resources in the process.

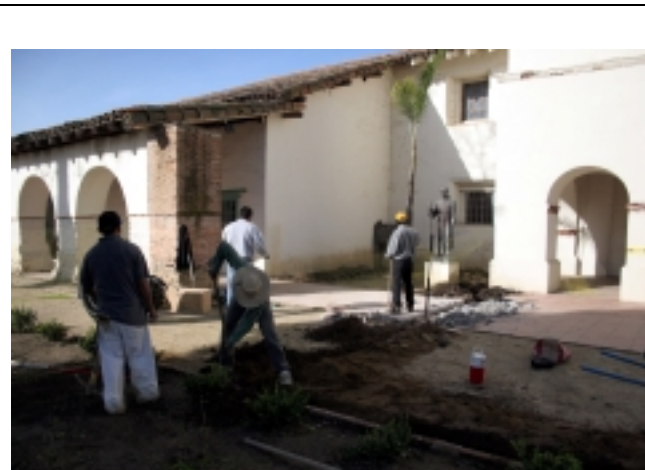
The trenching of the Victorian Tower Area resulted in the discovery of a 70 cm wide siltstone foundation. Because Mission period foundations at San Juan generally span 90 and 120 cm widths, I initially concluded that we'd stumbled upon an earlier Mission structure. Soon, however, I came to the realization that we'd actually recovered the siltstone foundations of the Victorian bell tower of the 1870s. Needless to say, this was a particularly exciting day for my students and I. During the course of archaeological monitoring we also recovered a Mission era bronze or copper "cuff link" replete with button and hasp, a few ceramic shards, and a couple of hand carved bone buttons. The discoveries in question in turn forced

Trenching operations exposed the foundations to the Victorian bell tower and revealed that the Serra statue was installed immediately atop said foundations. Photo © Ruben G. Mendoza, 2006.

me to revise the idea that the original Church plan included the laying of foundations for the construction of each of two bell towers that would have framed either side of the Church portico. Now, I can safely say that had the Church been completed, it would have incorporated a massive bell tower on a square footprint to the right side (or north half) of the front façade of the Old Mission Church. Ultimately, the negative drainage problem has been corrected and we can now begin to address the resulting damage to the historical resources of the Old Mission Museum and Archives Rooms.
