Ynformes de Sn. Jn. Bautista

A Report of the Mission Conservation Program of San Juan Bautista, California – Volume 1, Number 4 – April 7, 2006

Secrets from the Convento Floor

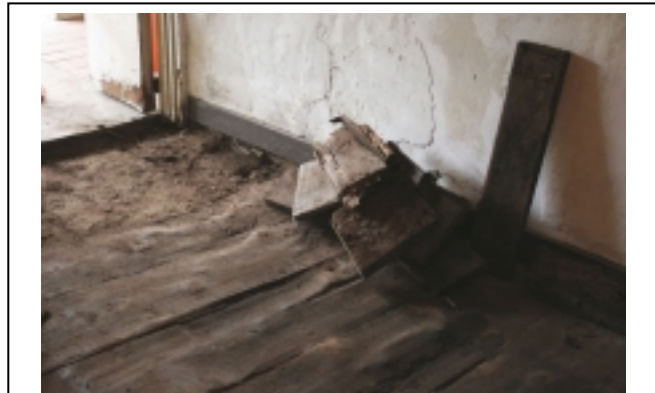
The rutted redwood plank floor at the threshold of the Museum entryway was so rotted by humidity that much of it had been reduced to the consistency of a wooden sponge. Photo © Ruben G. Mendoza, 2006.

Our solution was to remove and turn the planks in such a way that the rutted portions formerly located at the north wall were now positioned at the south wall. Each plank was turned 180 degrees, and then lifted from its original position and placed at the opposite side of the room (from east to west). By so doing, we effectively turned the entire floor 180 degrees. As a result, we now have an un-rutted, and safer, entryway floor area courtesy of the carpentry skills of Chuck Allen and his colleagues.

(particularly as the initial efforts to correct the floor spanned some three days), we soon learned that the redwood planks were ship lapped and adzed like those on the old sailing ships of the 18th and 19th centuries. This meant that we could not merely reverse individual planks and hope for a proper fit...and as such the whole of the floor had to be reversed. And, so it was that Chuck Allen, Fred Trujillo, Jim Quirke, Jesus Perez, Cesar Aguirie, and Raul Rocha reversed each plank and dug shallow trenches in order to bury 4” x 4” pressure treated support beams so as to properly stabilize and level the corrected floor.

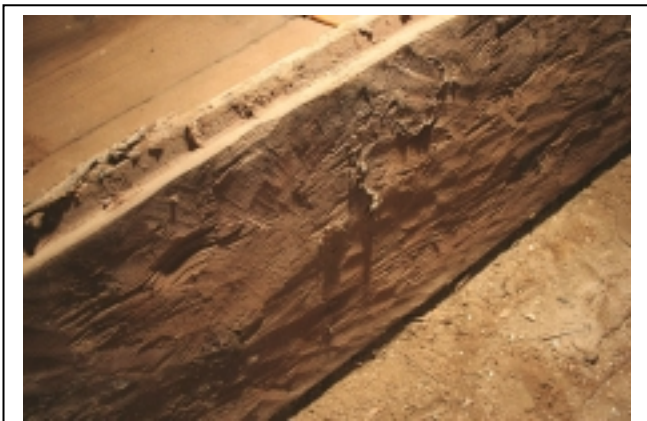
For those of you who like to keep track of such things, myself included, we measured and tested the old floor planks prior to their replacement. The floor planks varied in length, but averaged about 22 feet in length by 15 ¾ inches in width. The depth of each notch for the ship lapped portion of the beam varied from 1 ¼" to 1 ½" inches in depth. The heavily adzed portions of the boards that remain face down (so as to preserve the adze marks so recorded) measured approximately 11 ¼" in surface width. The depth or thickness of each worn plank varied between 2 ½" to 3". The planks required several workmen to lift as they clearly weighed well over 100 pounds each.

The redwood planks that compose the Convento floor were harvested from the Santa Cruz Mountains, and generally measure some 22 linear feet. Note ship lapped and adzed underside of plank. Photo © Ruben G. Mendoza, 2006.
